# Intel® Xeon™ Processor Specification Update

Release Date: December 2001

Order Number: 249678-009

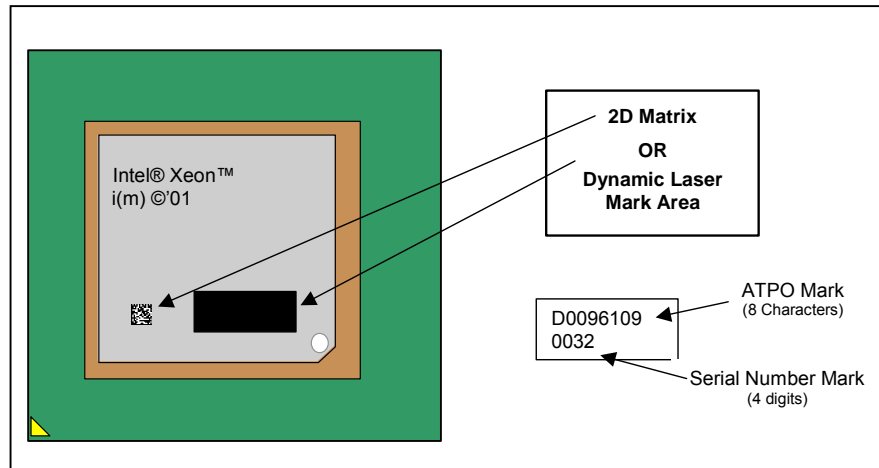
Figure 1. Top Side Processor Marking

### INTEL® XEON™ PROCESSOR MARKINGS (31 mm OLGA or FC-BGA)
